# FLOOD HAZARD ANALYSES

CITY OF CANBY AND VICINITY  
YELLOW MEDICINE COUNTY, MINNESOTA

U. S. DEPARTMENT OF AGRICULTURE  
SOIL CONSERVATION SERVICE

FEBRUARY 1973

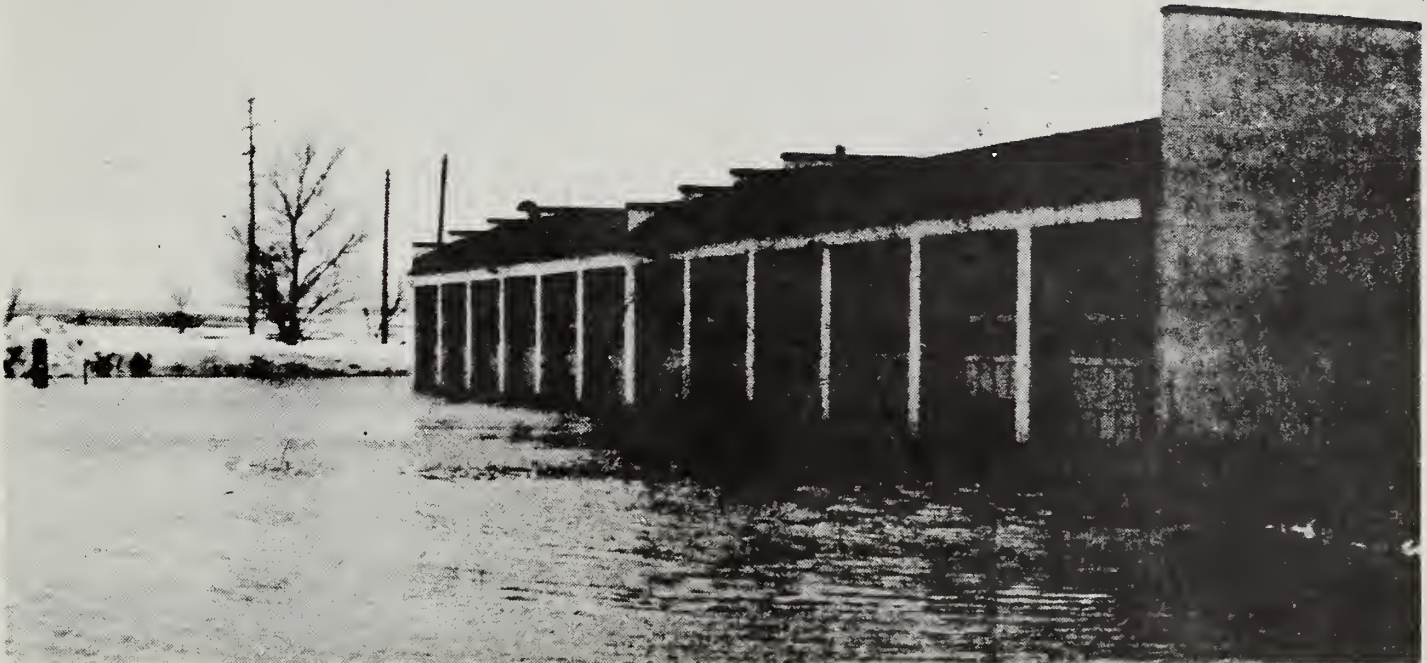
SORRY, NO BUS SERVICE today! Good Friday morning the waters rose and flowed through the school bus garage next to Highway 68 in Canby. The heating system was off the floor and little damage was done except for the mess, it was reported. The busses were all parked elsewhere Monday as the cleanup job commenced.

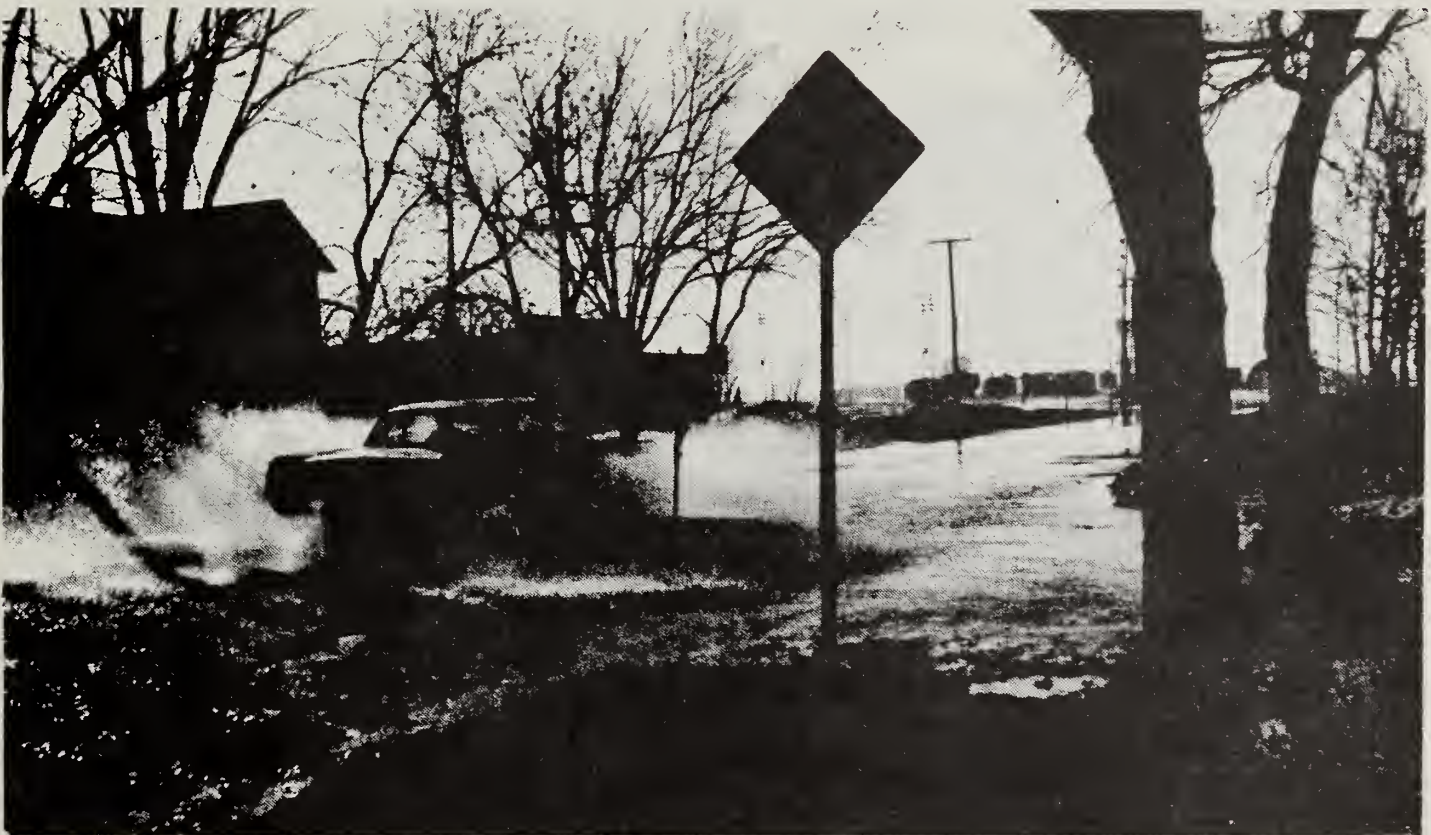
FLOOD WATER FLIES in all directions as a car heads west of Canby on Highway 68 about 4 p.m. Saturday. The water had come from the west drainage ditch, across the fields, athletic field, isolated the school garage and finally crossed the highway and onto lawns and into streets running northwest. Shortly after this picture was taken, a detour sign was erected as the water cut under the tarvia surface.

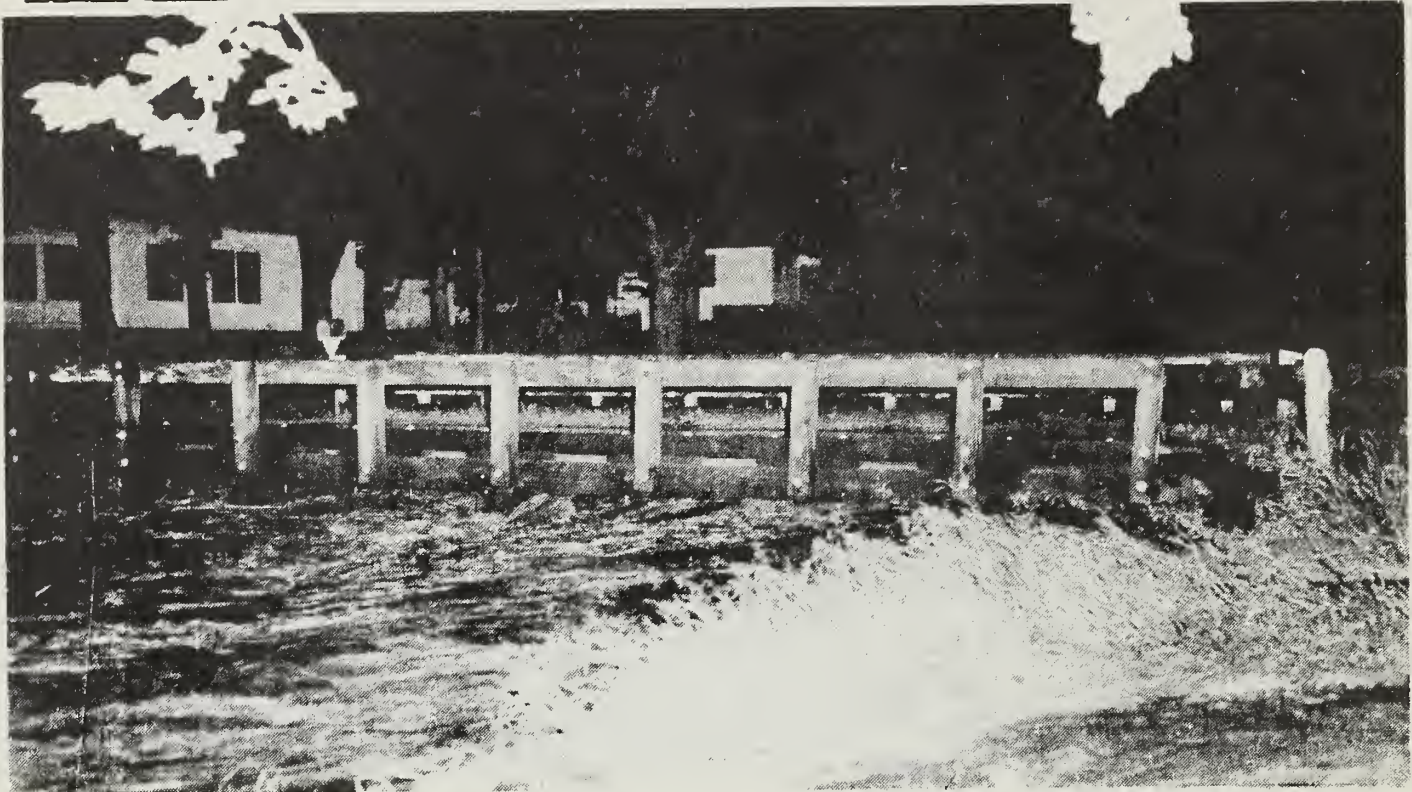
WATER, WATER everywhere was the scene at 3:45 a.m. June 16 as Canby just finished receiving its 3rd inch of rain in three days, the final 1.78 inches coming in just a few hours. This picture is of the intersection of 2nd St. East and Custer Avenue and the bridge over Canby Creek is just to the left of the picture. Vernon Maas is standing on the corner watching the water which surrounded several homes next to the creek. Just a couple hours later, the water had subsided and was back in the creek bed, but as it continued downstream, it washed out bridges and culverts and cut up roads.

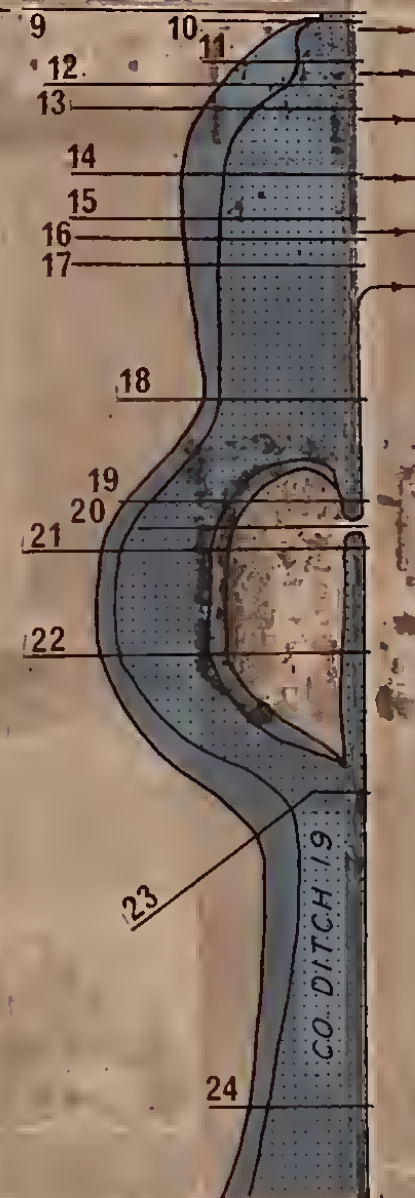
SHEET 3 OF 12

100 YEAR FREQUENCY FLOOD AREA (EXISTING CONDITIONS)
-

MATCH LINE - SEE SHEET 2

MATCH LINE - SEE SHEET 4

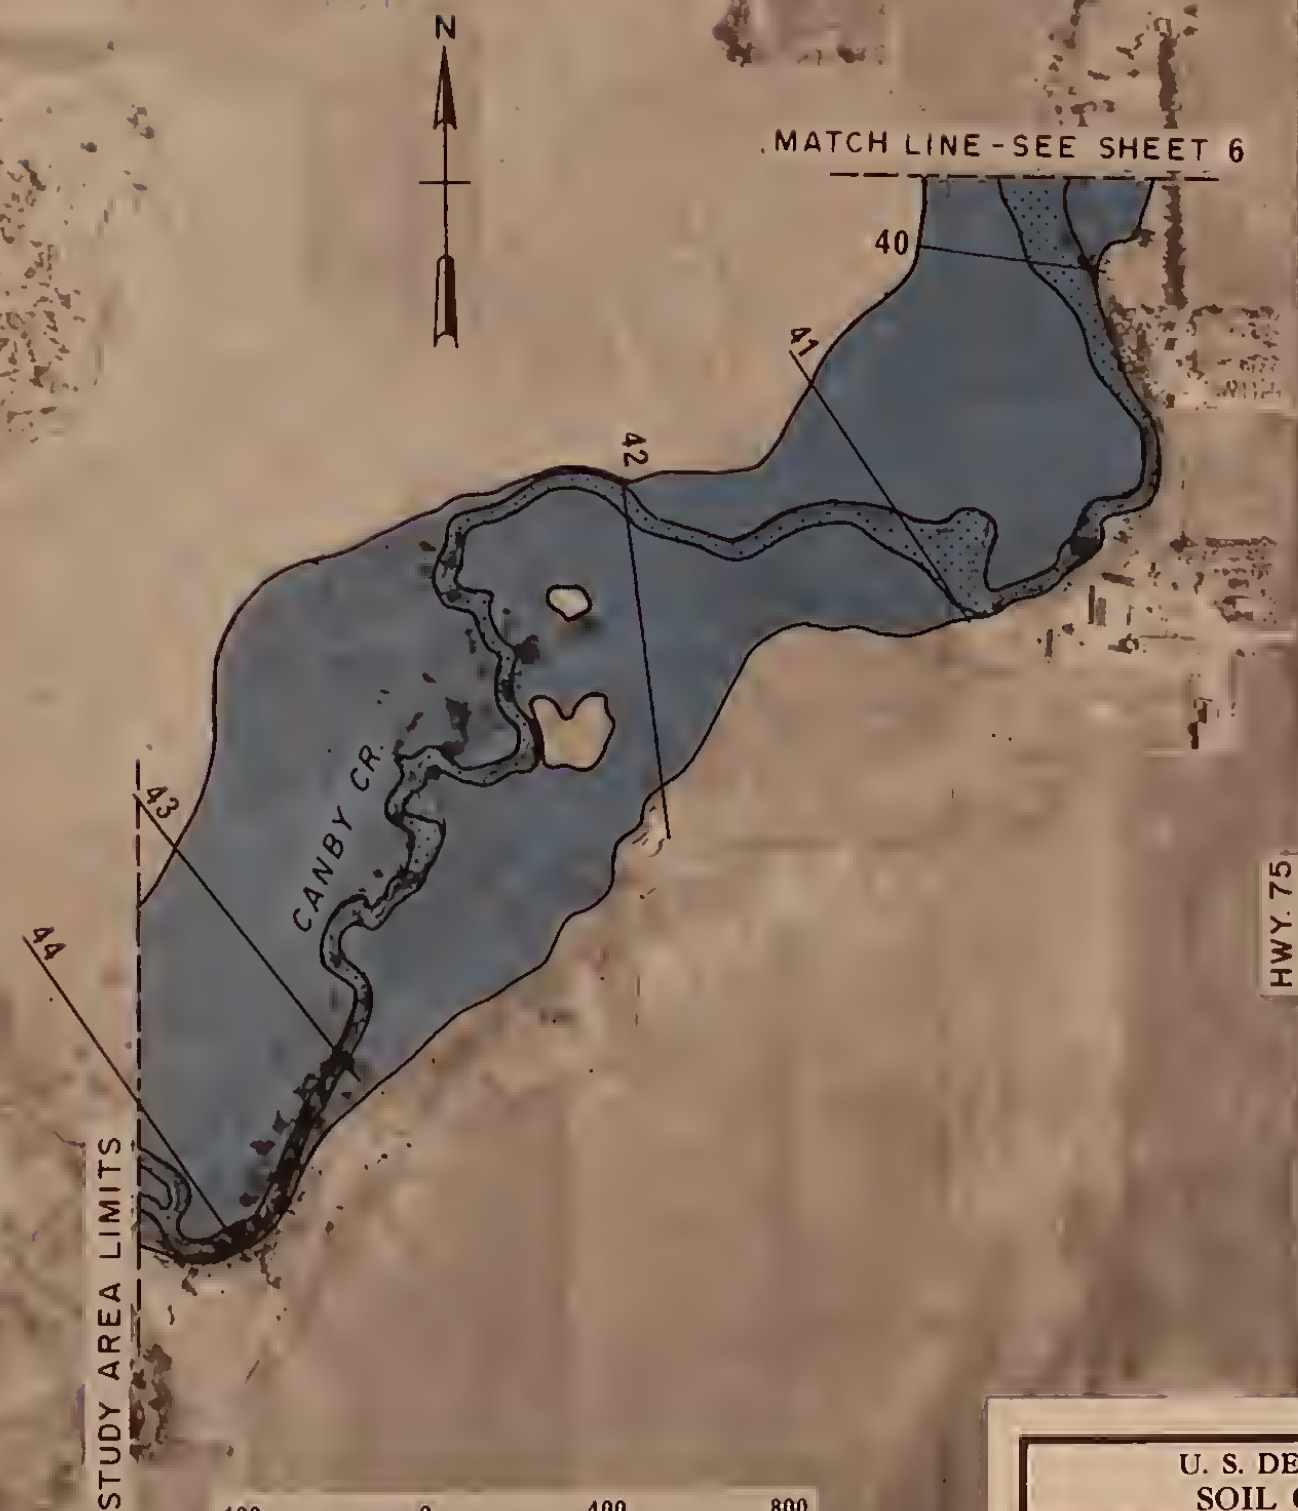
FLOOD HAZARD AREAS-CITY OF CANBY  
YELLOW MEDICINE COUNTY, MINNESOTA

43 VALLEY SECTION

LIMITS OF FLOODING SHOWN MAY VARY  
FROM ACTUAL LOCATIONS ON THE GROUND

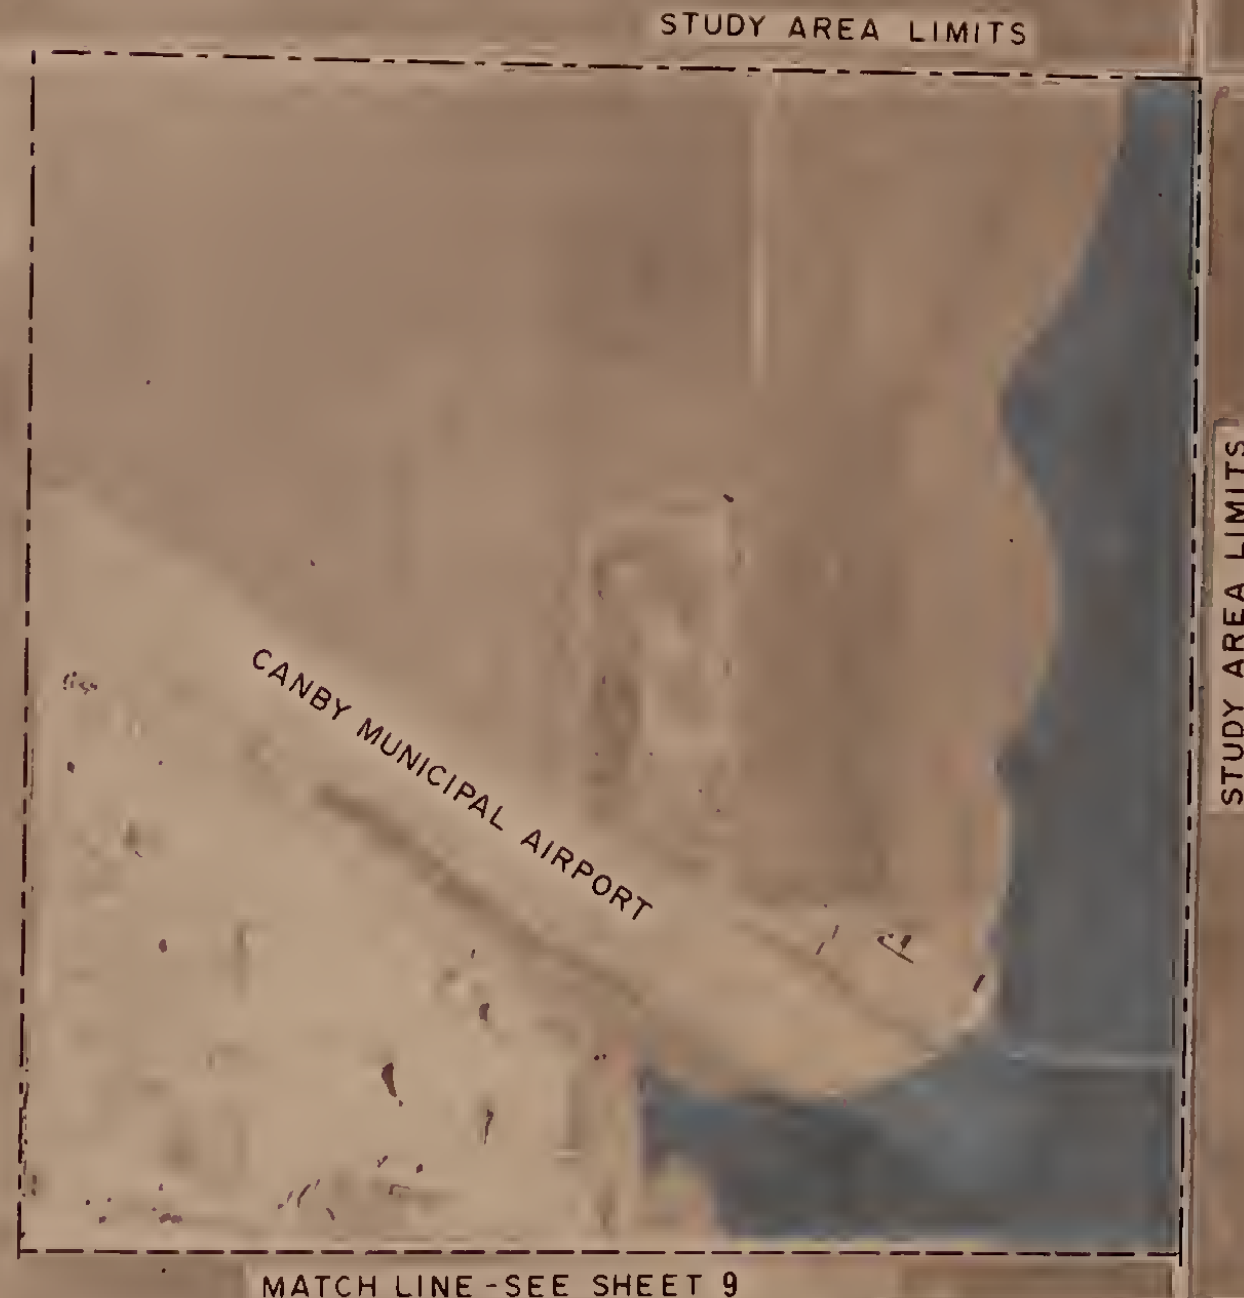
**FLOOD HAZARD AREAS-CITY OF CANBY**  
YELLOW MEDICINE COUNTY, MINNESOTA

VALLEY SECTION

LIMITS OF FLOODING SHOWN MAY VARY FROM ACTUAL LOCATIONS ON THE GROUND

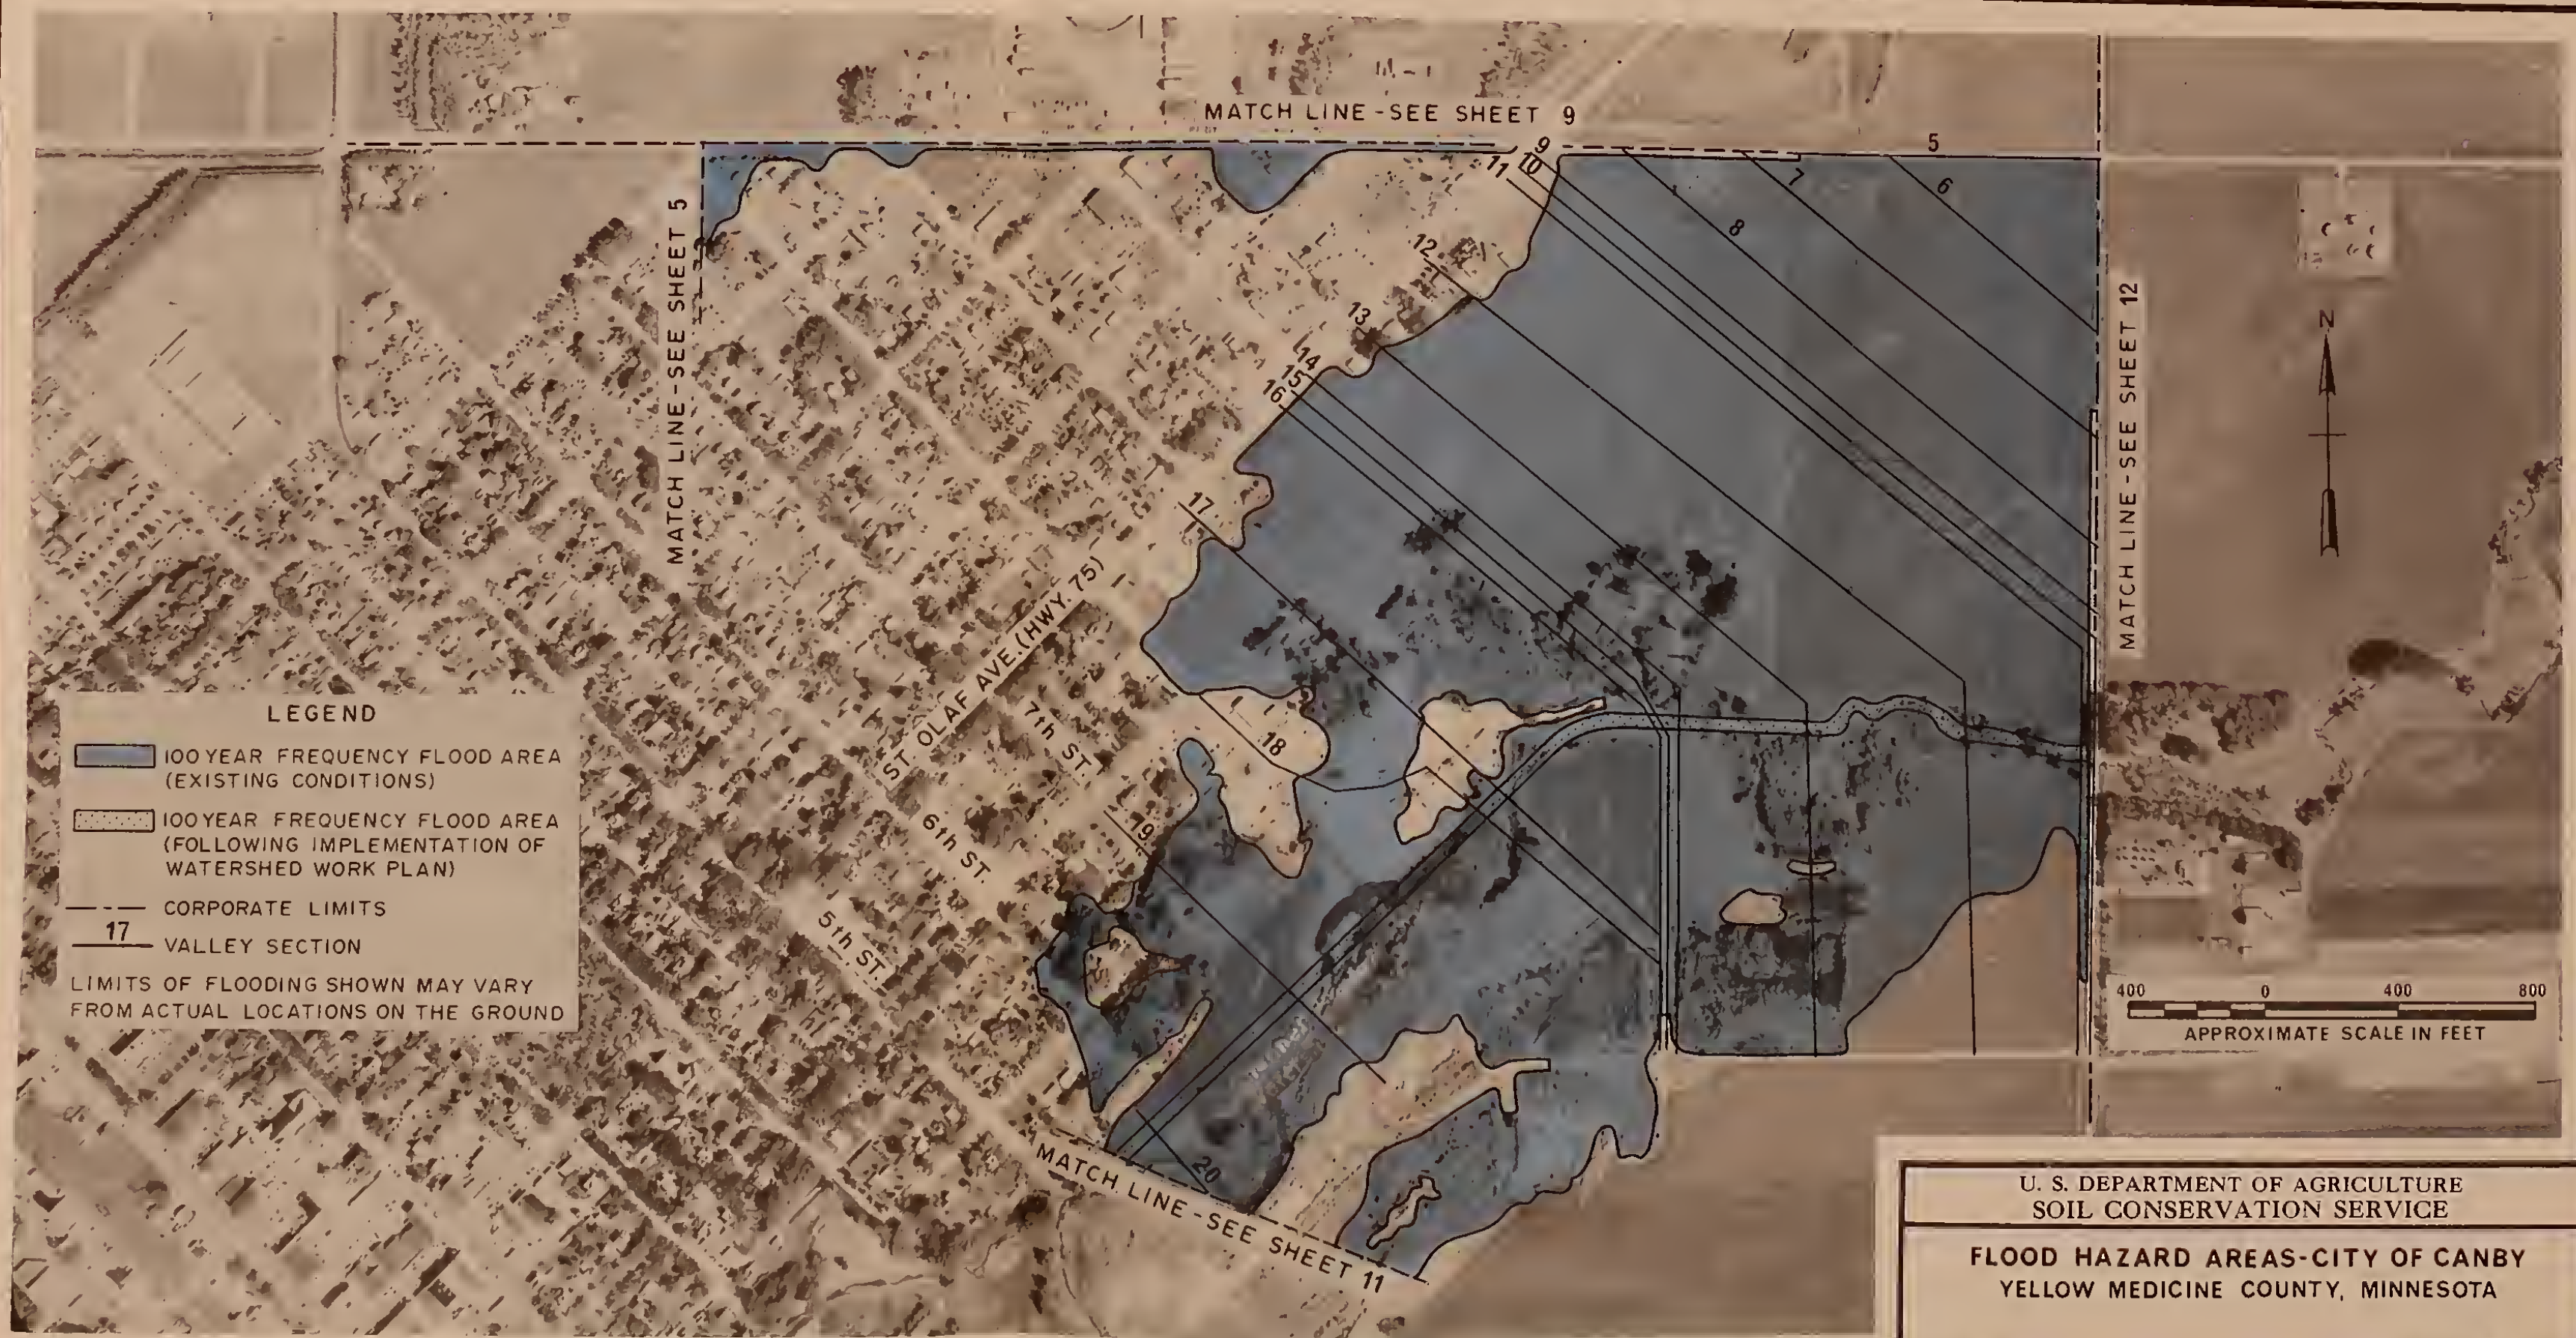
SHEET 9 OF 12

- 100 YEAR FREQUENCY FLOOD AREA  
(EXISTING CONDITIONS)
- 100 YEAR FREQUENCY FLOOD AREA  
(FOLLOWING IMPLEMENTATION OF  
WATERSHED WORK PLAN)
- CORPORATE LIMITS
- 17 VALLEY SECTION
